1234 Main St City FL 12345 INSPECTED BY Jason Rohter Southern Oaks Property Inspectors HI10681 INSPECTION DATE 7/2/2021 0 02:00 PM

Property Address 1234 Main St City FL 12345

Report ID 20210702

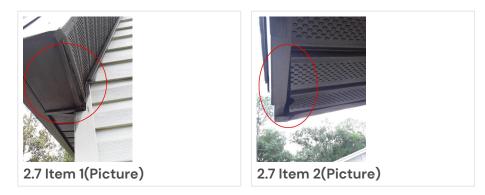
2.7 EAVES SOFFITS AND FASCIA

We're finding a couple areas in the soffits that the connections between the flashings and the eaves aren't really that good and nails popping. We recommend a licensed contractor estimate repairs around all your soffits to create a good seal so nothing can get up in your soffits.

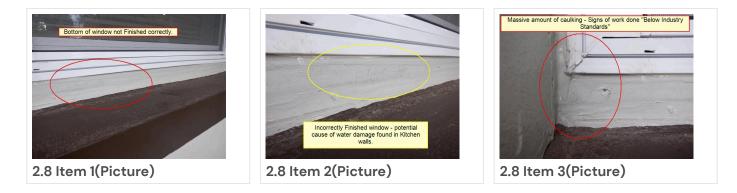
2.8 WINDOWS (A REPRESENTATIVE NUMBER)

The front of the home has had new windows installed. Back to the "Below industry standards" comment from the roofing section. This is not how the finish should be. The backer board is showing the print from the material. This, along with the screw-holes not sealed and covered the material is "Raw" not finished. There should be at the very least enough paint to cover the labels. We also were able to push on the windows and they are moving. We looked for permits and came up empty.

We have no problems with most of the work in the home being done without Permits "if" the work that we are seeing being done was done correctly.

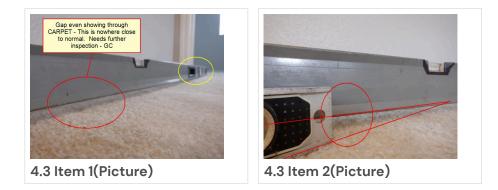
4.3 FLOORS (STRUCTURAL)

I was going to save this for the "Inside Flooring" section but to rule out any structural damage you would need to remove carpet and Plywood subfloor to get to the root cause of the 2" - 4" dip in the floor upstairs.

Here was have a bathroom and family room that connect to two back rooms. Right before you get to the back rooms the floor has a large dip. The dip continues under the wall that is connected to the bathroom.

We can only speculate that the bathroom has had a leak and has caused damage to the floor joists on the top floor. This amount of dip in the floor needs to be looked at by a General Contractor (in my opinion) to ensure that this area is safe for adding weight and living.

It could be that this area is strong and secure but, I feel obligated to make you aware this is not Normal and strongly suggest you have a second opinion prior to closing.

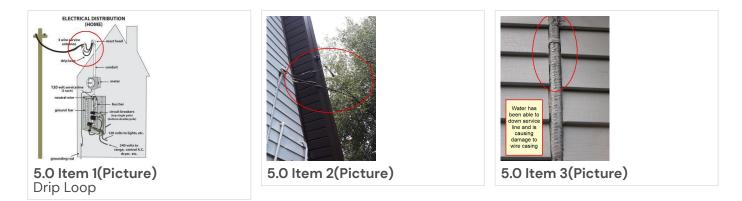
5.0 SERVICE ENTRANCE CONDUCTORS, SERVICE DROP

The "Service Entrance Lines" are missing "Drip Loop"

A drip loop, is a loop or dip in the service entrance lines right before they enter the service mast conduit on the roof. ... The drip loop prevents water from entering the service mast and ultimately, protects your electrical panel from becoming wet on the inside. The drip loop is **required** to keep water from traveling along the length of the service-entrance conductors and entering the service-entrance conduit at the weatherhead.

With the water able to travel down the wire, we are finding damage to the wire casing on the side of the home. Now this has taken place over years but, it does pose potential damage and problems in the future. We recommend contacting a Licensed Electrician for further evaluation and repair cost.

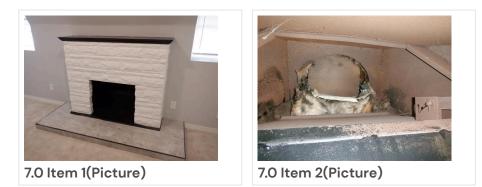
Fireplace is very pretty but not in working condition. The chimney has been closed off. This fireplace is not a working fireplace at time of inspection. Do NOT USE FOR FIRES

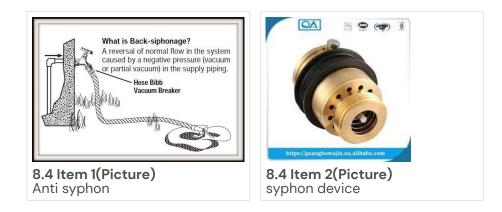
We inspected all exterior hose bibs and found one or all of them have missing Anti-Syphon valves.

The hose bib anti-siphon valve prevents outside water from siphoning through an outside faucet and contaminating the drinking water used in your home. This valve is easy to install and fits all standard outdoor hose faucets. Its durable construction provides years of reliable use.

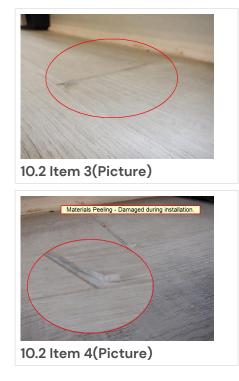
(1) Both floors upstairs and downstairs are less than flat. There are "flatness" requirements for most floor coverings when installing. These installation standards were not met on the downstair flooring and the new flooring is showing signs of damage (installation errors).

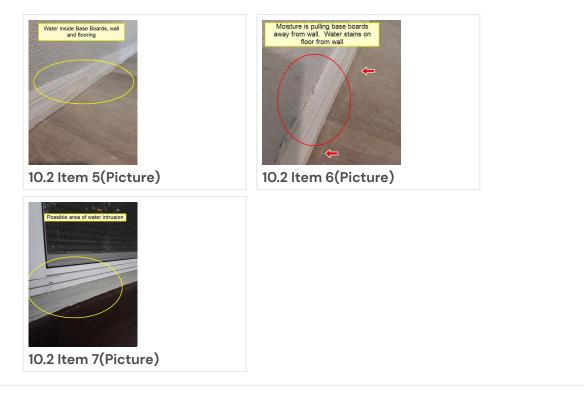
(2) Towards the front of the house inside the kitchen just off the island we are seeing signs of previous moisture in the wall that's on the floor and in the walls and baseboards to look into this further you have to take the baseboards off and see if there's evidence of moisture in the walls we recommend if looking further for a general contractor to assess what's causing this damage From the outside to the kitchen area we are seeing a newly installed window where under the window there still raw materials with holes in the wall this could be creating some sort of moisture intrusion we recommend a general contractor evaluate this window installation repair and replace as desired
